**KOMITE NASIONAL KESELAMATAN TRANSPORTASI
REPUBLIC OF INDONESIA**

Aircraft Accident Investigation Report

ATR 42-500; PK-THT

17 January 2026

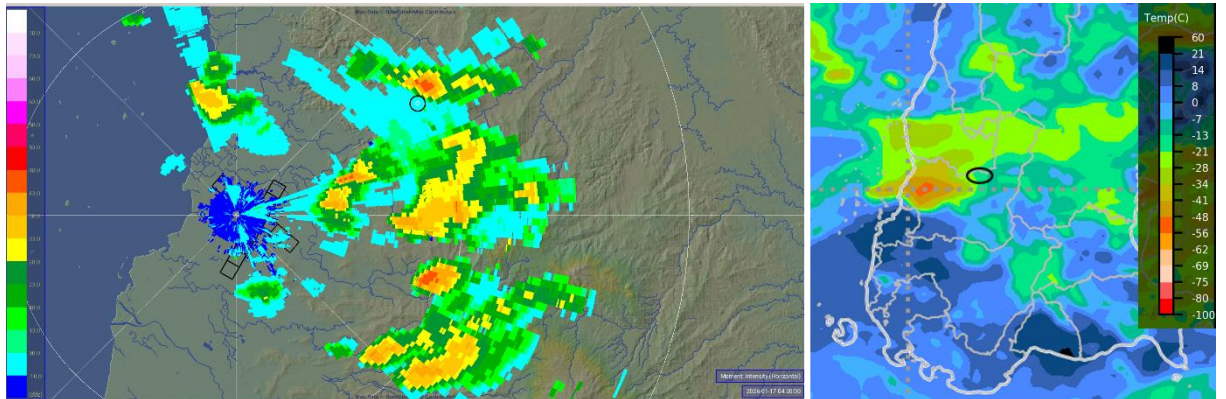
Figure 3: Weather radar image (left) and satellite image (right) at 0420 UTC

The weather radar and satellite imagery at 0420 UTC indicated the presence of convective cumulonimbus clouds around the accident site (annotated inside a black circle in Figure 3).

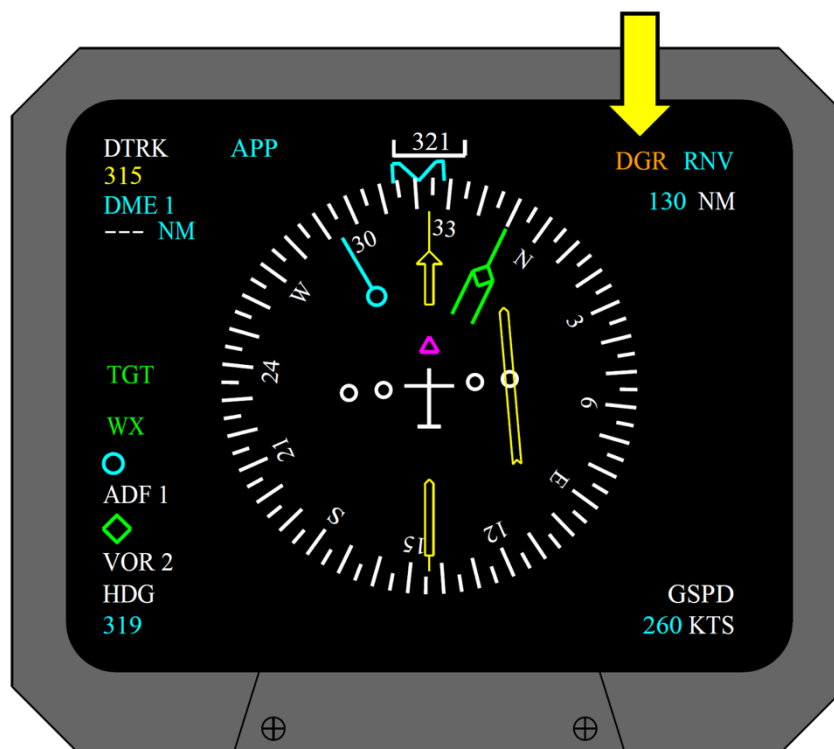
Figure 6: Typical DGR alert message in the EHSI (annotated in yellow arrow by KNKT)

When the HT1000 system enters a degraded mode, the amber DGR alarm display will be displayed in the EHSI as shown in Figure 6.

FCOM Chapter Description (DSC). Subchapter 2.5: EHSI - Full Mode, describes that DGR illuminates in amber on the EHSI when the “UNABLE RNP” message is displayed in the MCDU. The “UNABLE RNP” message displayed in the MCDU can trigger an External System Warning “RNV MSG (1)” in the Electronic Attitude Director Indicator (EADI).

- When there is an indication of navigation system degradation, pilots are required to verify the aircraft position using conventional means and/or revert to an alternative means of navigation in accordance with the applicable operational procedure.

- The aircraft operator must ensure that pilots implement applicable operational procedures when there is an indication of navigation system degradation.

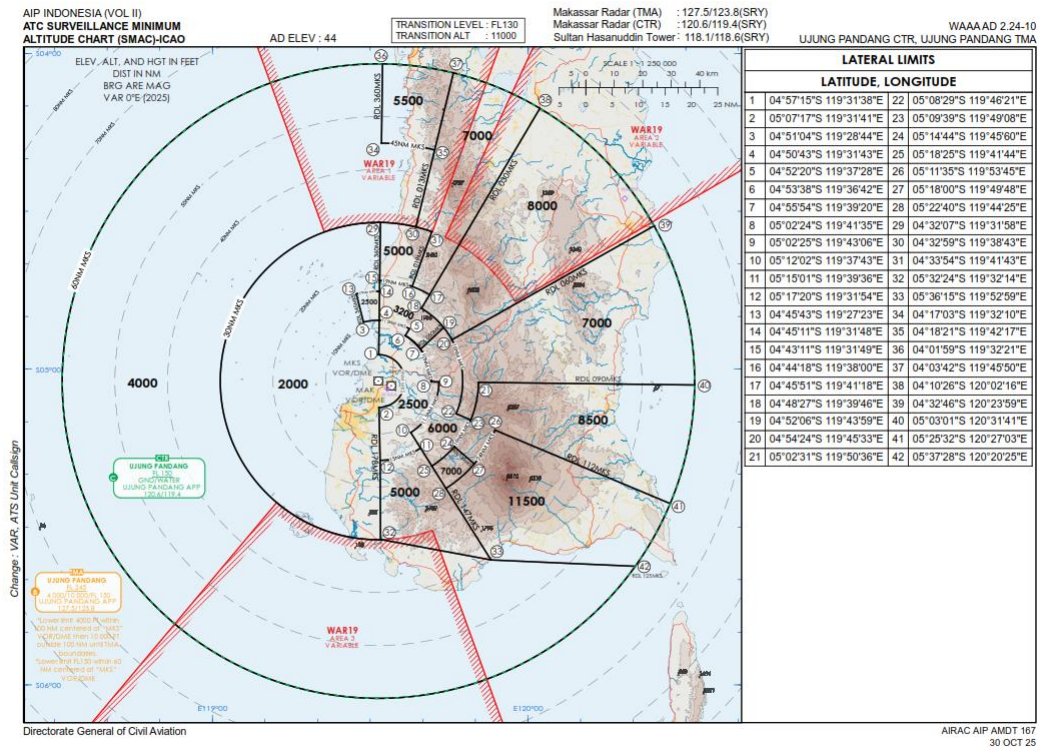
Figure 8: ATC SMAC within the Ujung Pandang Control Zone (CTR) and Terminal Area (TMA)

to cross-check assigned altitudes during terminal operations. The accident site (Mount Bulusaraung) was within an ATC SMAC of 6,000 feet.

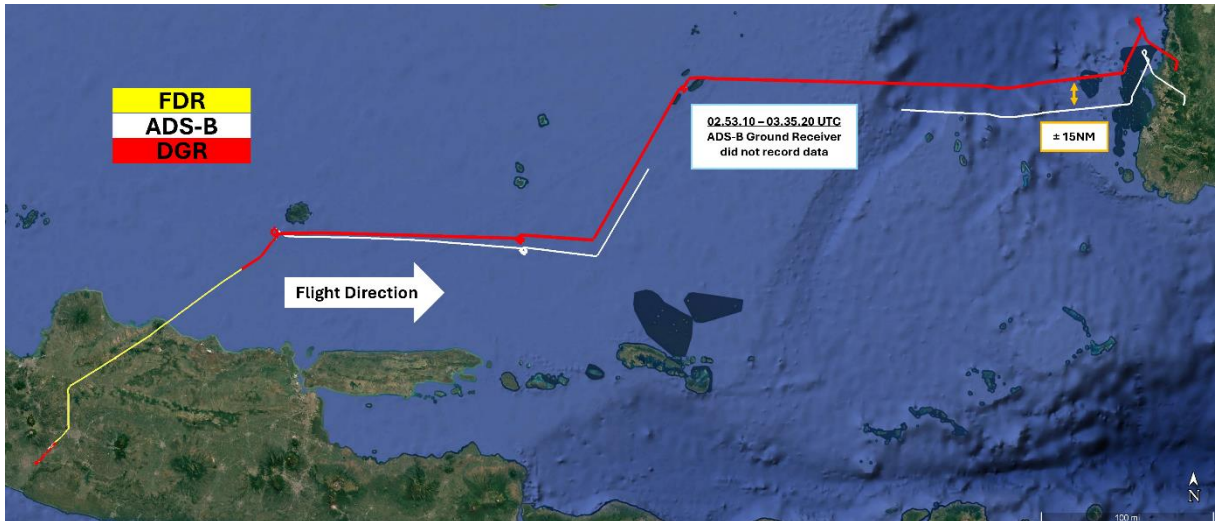
Figure 9: Aircraft trajectories based on FDR (yellow line) and ADS-B (white line) with Degraded mode (red line)

The accident flight record indicated that since the FDR began recording data (when one of the engines had been started), the parameter of GNSS Degrade indicated that the aircraft GNSS was in Degrade mode (DGR). When the aircraft climbed, passing an altitude of 7,700 feet, the GNSS Degrade parameter recorded Not Degrade. The GNSS Degrade parameter recorded DGR again about one minute before the aircraft descended from the cruising altitude of 11,000 feet, and the DGR remained until the end of the FDR recording.

The accident flight record also indicated that since the FDR began recording data, the coordinates recorded on the FDR indicated that the aircraft was 1 NM southeast of Adisutjipto Airport. When the ADS-B ground receiver started to receive the broadcasted data from the aircraft, as the aircraft climbed passing altitude of 5,900 feet, the position of the aircraft was about 0.6 NM northwest of the aircraft position recorded in the FDR, and the distance continued to reduce (aircraft trajectory from FDR data was getting closer to the trajectory from ADS-B data). When the aircraft

climbed, passing an altitude of 7,700 feet, the aircraft trajectories from FDR and ADS-B data were superimposed. The aircraft trajectory from FDR data and ADS-B data started to split again when the aircraft was descending to an altitude of about 2,000 feet. The distance between two trajectories increased gradually up to 17 NM until the end of FDR recording.

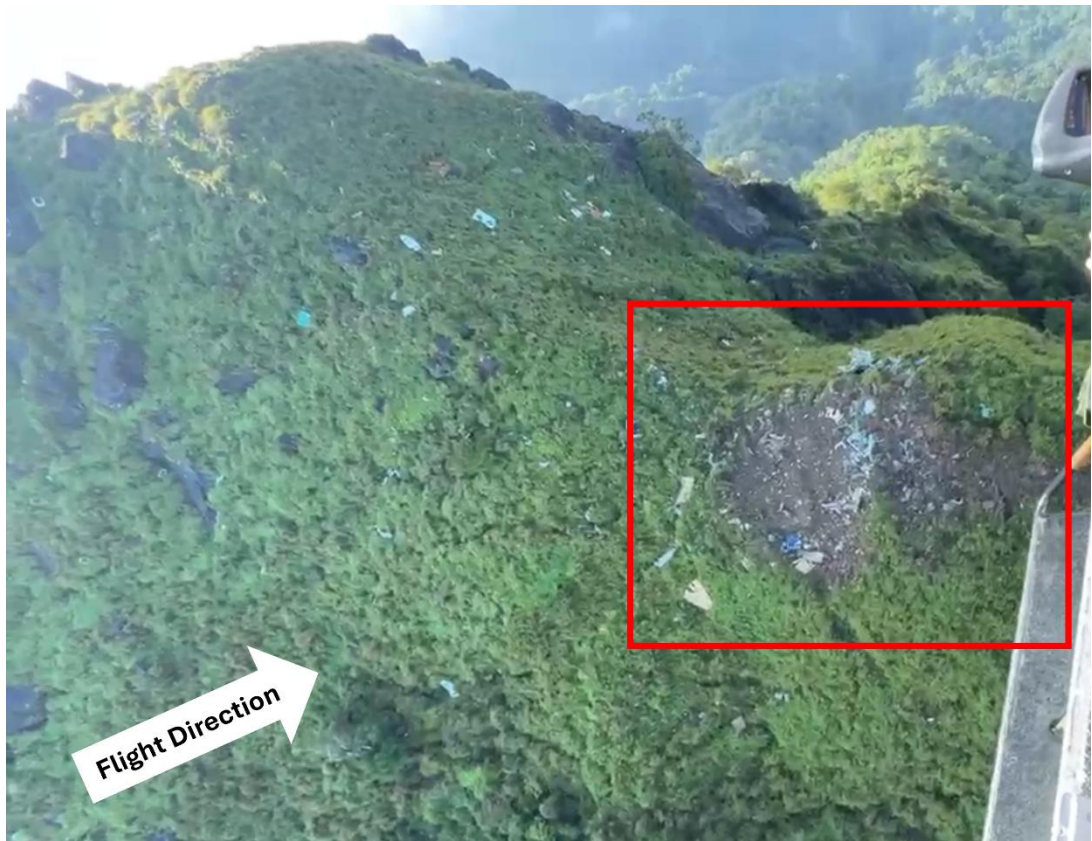
Figure 10: Initial impact mark (inside the red square) with illustration of the flight direction

The initial impact location (see Figure 10) was at the coordinates of 4°55'44.37" S; 119°44'50.008" E at an elevation of about 4,300 feet above mean sea level (AMSL). The wreckage was scattered about 700 × 200 meters on the slope of about 80° (see Figure 11).
